# **Facility Assessment and Fire Station Location Analysis**

## **Concord Township Fire Department**

**The Ohio Fire Chiefs' Association**

**March 2017**

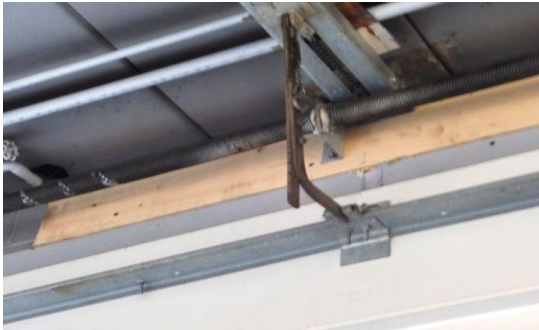
All four bays have electrically operated 13' wide x 12' high overhead doors. They are equipped with emergency release levers that will permit manual door operation in the event of a power failure. However, the emergency release cables terminate at the connection point to the operational chain; personnel must use a pike pole to reach and activate the release lever. An emergency release cable for each door should be installed and rerouted to the front of each bay door by rope and positioned in such manner to allow immediate activation by personnel without

the use of any special tools or the need to climb on an apparatus. None of the doors are equipped with electronic door sensors for emergency stopping or reversing direction, nor is there a warning system designed to provide a visual or audible warning that a door has not fully opened. Ceiling height of the bay area is just over 12', leaving minimal space for the overhead bay doors to raise parallel to the ceiling when opened. There are no external bollards installed to protect the building at bay door openings. The size of the bay area is 32' x 34'. Each bay floor has a raised-wheel stop that serves as a striking stop point for each apparatus' left rear tire.

Overhead door emergency releases

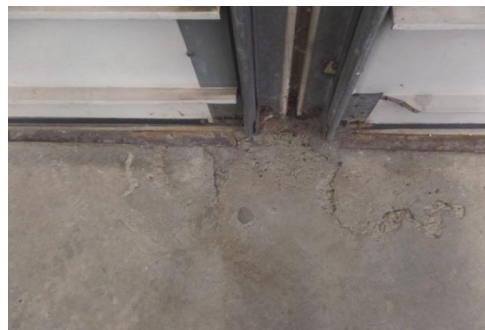
The floor in the bay area is unsealed concrete that is deteriorating due to spalling.

Concrete floor spalling

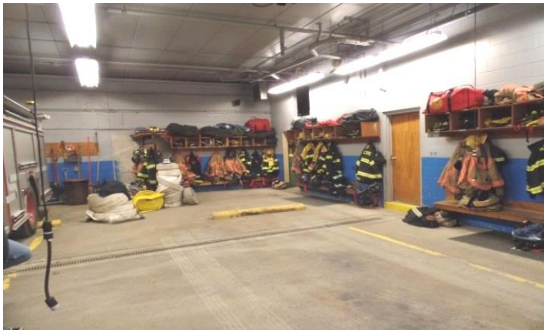
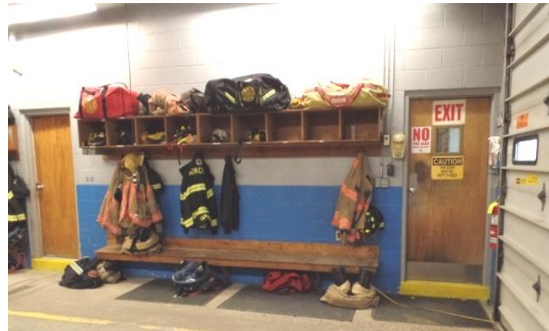
The west bay wall contains the stairwell to the second floor, the main vestibule entrance to the station and the office/dorm area utilized by the shift commander. Along the exterior wall/floor section of this wall there are two entrance doors into this area which sit on top of a 5” step-up. This is designed to prevent hydrocarbon fumes or bay-floor water from entering the living quarters and administration portion of the building. A third door is located at the south end of this wall that allows access to the boiler and storage room. Firefighter personal protective equipment (PPE) is stored along the wall in individual storage spaces. The PPE is readily accessible to personnel and receives some air flow that would promote drying. The gear as observed did not show any damage from sunlight; however, lighting in this area is predominately provided with fluorescent fixtures, which have shown to degrade the outer shell material over time. The storage location of the PPE also potentially exposes the gear to debris that routinely would enter the station any time bay doors are opened.

Sections of the west bay wall showing lockers and 5” step-up to shift officer’s quarters

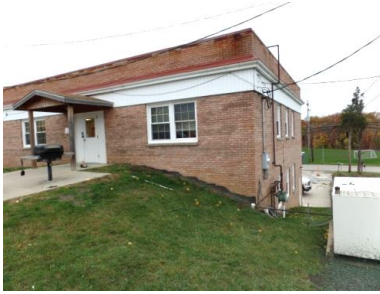
Entrance doors at both the lower and upper levels are showing deterioration due to rust and aging, with the interior floor also showing extensive wear characteristics. The parking lot also is showing signs of deterioration with numerous cracks that may contribute to further deterioration.

Second floor entry

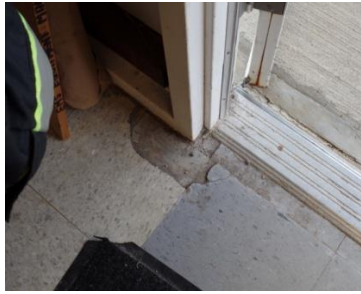
Second floor condition

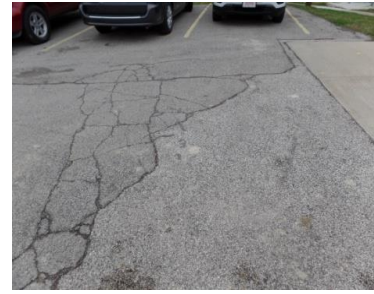
Black top condition

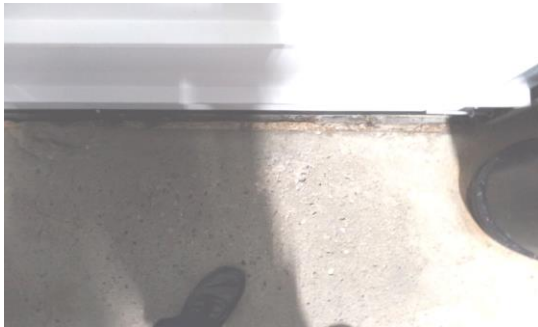
Bay floors are not sealed and are beginning to show signs of spalling and deterioration. This was especially noted near bay door openings that expose this portion of the bay to the elements.

Concrete floor spalling

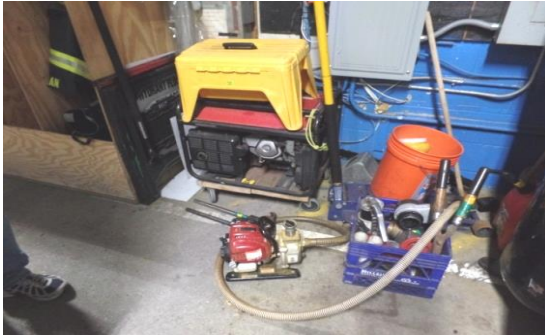
the station through the normal electrical system. However, the unit supplies limited electrical capacity to the station, requiring personnel to limit its use by ensuring numerous electrical devices are turned off or disconnected.

Portable generator

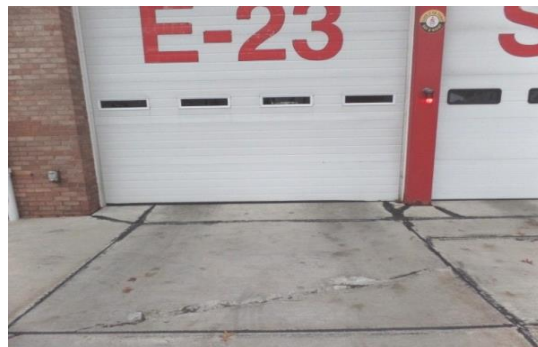
The ramp area is a concrete pad approximately 93' long x 73' wide at the bay doors, tapering to a width of 43' where the ramp intersects with Prouty Road. Concrete parking space is developed off both sides of the ramp sufficient to hold four or five vehicles on each side. The concrete pad, which was replaced in 2008, has numerous cracks and is beginning to show signs of deterioration.

Concrete pad deterioration

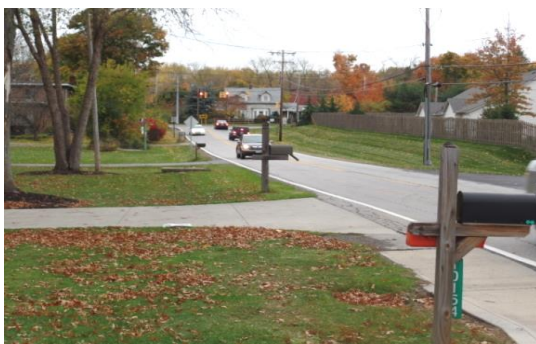
Safety concerns exist for emergency response vehicles exiting the station and the motoring public. There is limited line of site looking south on Prouty Road that makes it difficult to turn north out of the station onto Prouty Road. The speed limit for this section of Prouty Road is 35 MPH and the road is heavily traveled at certain times of the day. During these heavy travel times, the department has experienced situations where the northbound traffic has stacked up near or in front of the station. At times, this has resulted in perilous northbound travel under emergency conditions, especially if the apparatus must travel in the southbound lane due to the

Line of sight looking north

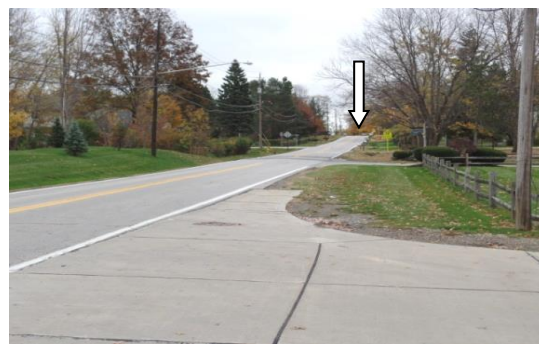
Line of sight distance from the south is questionable as there is a rise in the roadway 1000' from the ramp that obstructs the view of traffic beyond that point in the roadway. The state of Ohio routinely uses the Ohio Department of Transportation's *Location/Design Manual (Vol 1)* for line-of-sight visibility distances and other related matters. Chart 201.6 E "decision sight distance", references 980' to 1,125' of visibility. In snow or ice conditions, an engine attempting to start up the ramp towards the highway entrance may not be able to gain enough traction in a timely manner to safely enter the roadway. However, numerous states' DOT standards suggest a line of sight greater than 1,200' to 1,400' for a heavy, commercial-type vehicle to exit onto a main roadway safely. The department may wish to consider working with the Lake County Engineer or the Ohio Department of Transportation in developing a robust highway egress plan with the goal of improving operational safety for both the motoring public and department personnel.

Line of sight looking south; road rise noted

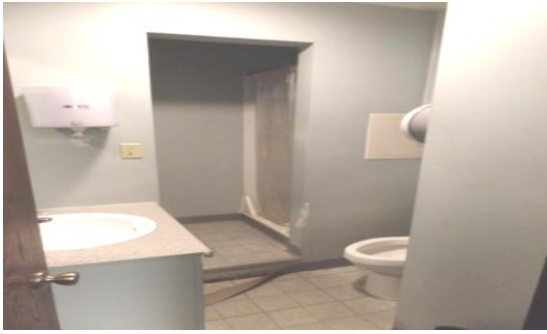
In the original restroom area the rubber kick molding is coming off the wall leading into the shower area. Deterioration was noted to the wall just above this point as well as other areas in the room. Although mold was not observed, the lack of an air circulation system along with the presence of moisture creates an environment conducive for mold to grow. Regular cleaning with anti-mold cleansers and solutions is necessary to prevent mold development. There were no lockers available for personnel to use in either restroom area. The restroom/showers were not designated for male or female usage, but the entrance doors have locks that would allow the door to be secured during their use.

Original restroom/shower

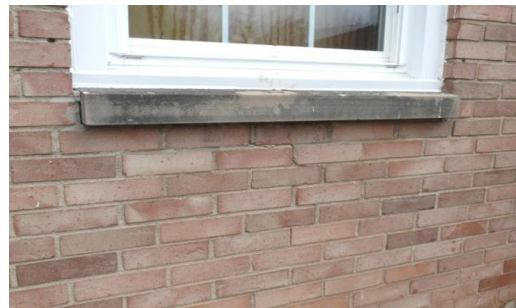
The exterior of the building is covered with brick veneer and vinyl siding. The siding was in good condition. However, it was noted the brick mortar is cracking, causing gaps between bricks in different places. This was especially noted in the south wall of the building.

South wall mortar cracking
