# **Facility Assessment and Fire Station Location Analysis**

## **Concord Township Fire Department**

**The Ohio Fire Chiefs' Association**

**March 2017**

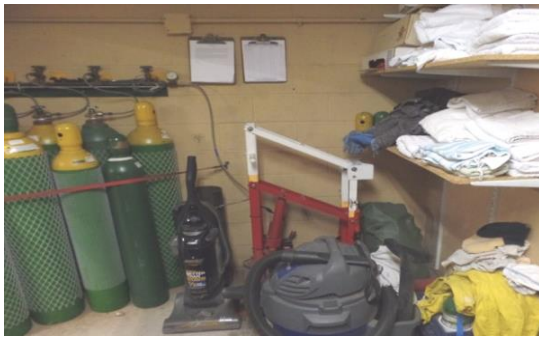
West wall storage room-oxygen cascade system

The third door, located at the south end of the west wall, opens into two rooms. The department’s three-cylinder cascade oxygen system is located on the south side of the first room, along with portable oxygen cylinders. The cylinders are properly secured and those not in use are capped appropriately. This area also has a fragmental tube previously used for the filling of D- and E-sized portable oxygen cylinders.

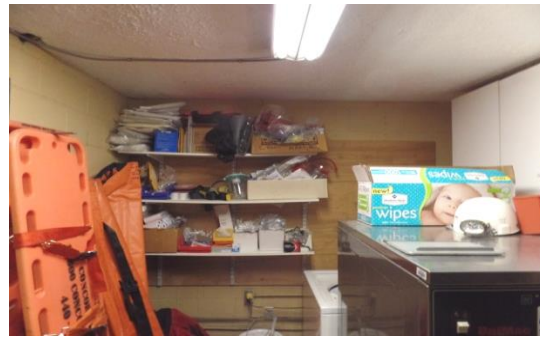
West wall storage room-EMS items & washing units

The southwest wall of this room has wall shelving that contains an assortment of towels and cleaning rags. The north side of the room has wall-mounted cabinets and half-wall shelving for storage of EMS and other supplies, as well as EMS backboards. Two washing machines are located in this area; one for general purpose cleaning and the other is an extraction unit designed to clean department PPE. Located next to the washing machines are containers of cleaning concentrate pre-plumbed to the extractor and cleaning solution for the general washing machine. Modern electrical conduit and outlets are installed for the washing equipment; however, there is no indication the outlets were GFCI protected.

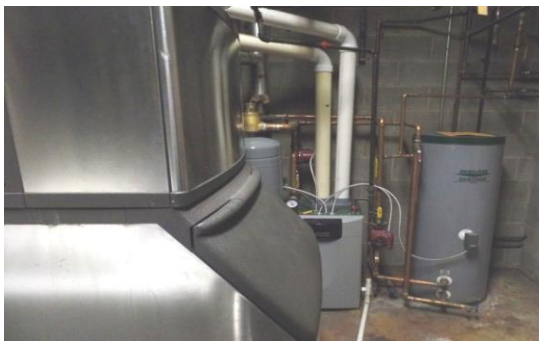
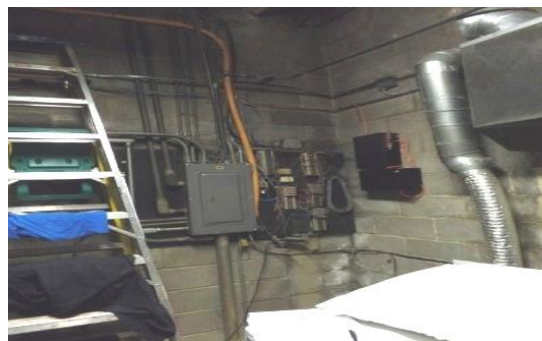
Mechanical Room

The mechanical room is located behind the oxygen cascade storage room and only accessible by walking through the cascade storage room. Facility operational equipment is located in this room including a residential hot-water heater, boiler for apparatus bay heat, telephone termination punch-down board and telephone control box, computer access terminals, electrical panel, station alert system, clothes dryer and ice machine. The access door into this room is protected by a one-hour-rated fire door. The room also had a step ladder with articles of clothing hanging on it at the time of the inspection. In addition, two sets of PPE and helmets were located in the area as well as a variety of containers. A designated mechanical room is required to be kept clear of storage type items (step ladder, clothing articles, etc.) to ensure the functionality and integrity of the operational space. The dryer and ice machine should be located in a different room than the mechanical room. The dryer discharge was "plumbed" into a residential flex hose with discharge into an external plenum.

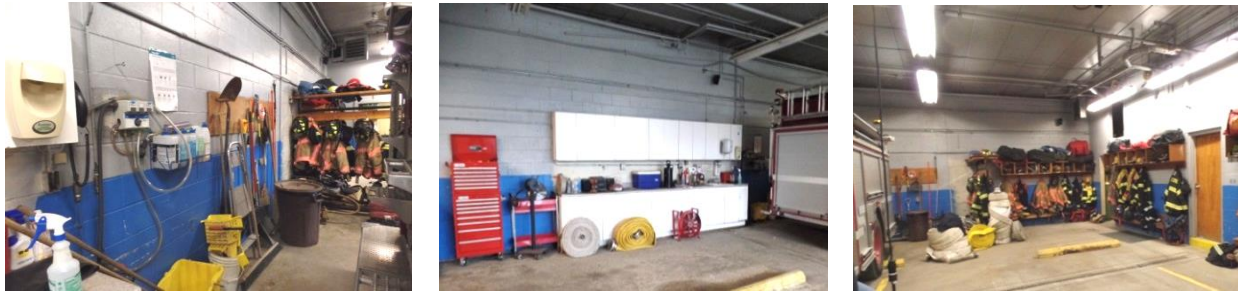
South bay (rear) sections of Station 1

The south or back wall of the apparatus bay has an assortment of cabinetry with a countertop and sink. There is a workbench, roll-around tool box, storage of hand tools and a chemical cleaning dispenser system in this area. Large items stored in this area include a portable pump, stacks of rolled hose and a portable hose loading table. PPE lockers are located on the south and west bay

walls. The automatic transfer switch for the department's emergency standby generator is also located in this area.

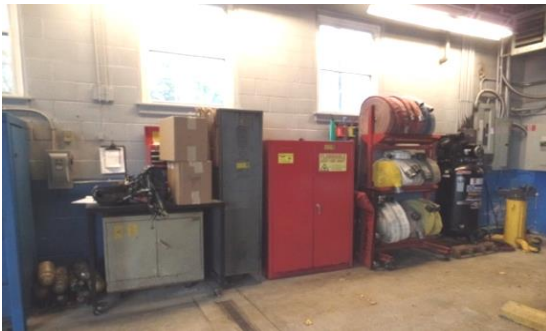
East wall

This area has a flammable liquid storage cabinet, portable hose rack, portable industrial vise, an 80-gallon general-use air compressor, moveable work bench, and a self-contained breathing apparatus (SCBA) storage cabinet. The workbench had SCBA equipment stored on it and an exit door near the front of the bay is partially blocked by the SCBA storage cabinet. There are three electrical panels located on the east wall and they appear to be properly installed. There are no signs of distress or wear, but some of the circuits are not labeled. This area has three double-hung windows for natural lighting and a bollard on the right side of the interior east bay designed to protect the department's breathing air compressor.

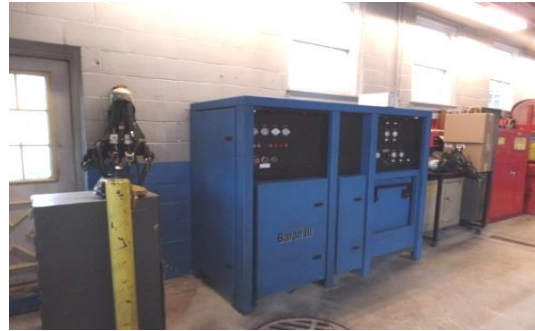
Air compressor

The breathing air compressor was purchased in 2004 and is an Eagle Air Baron III, 4,500 psi compressor for filling the department's SCBA cylinders. The compressor receives make-up air from exterior atmospheric air through installed piping. Air quality sampling is done biannually and the unit undergoes routine preventive maintenance. The compressor unit has the capacity to fill three cylinders at a time and is considered in good condition. The department fills air cylinders for neighboring agencies including the Auburn Career Center.

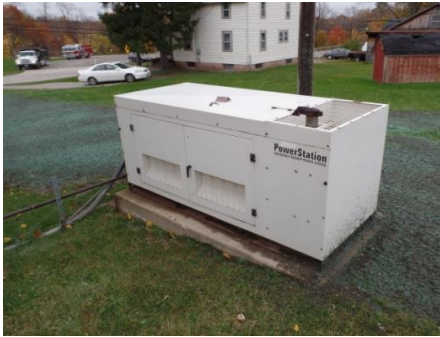
Generator

The building has a permanently installed Coleman 30 kW natural gas-fired external standby generator located at the southeast corner of the building. It is sized to fully support the electrical needs of the station as well as the networking support for the township's computer servers and telephone system. The system is equipped with an automatic transfer switch that enables the generator to start and transfer the building circuitry to the generator anytime the system senses the loss of normal electrical service.

The generator is professionally serviced twice a year with records retained by the department. The generator is programmed to automatically cycle once a week to exercise the unit, but this exercise does not place a load on the generator. The unit is routinely checked by department personnel.

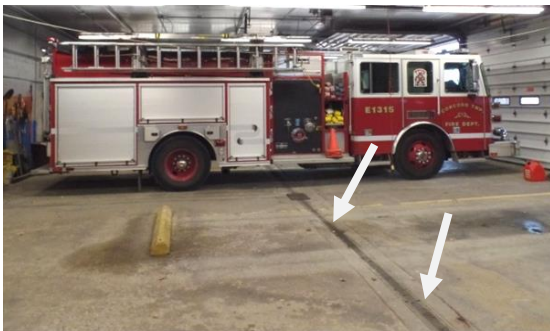
Drain system

Apparatus bay floor drainage was designed around a single 5" trench system that runs perpendicular through the center section of the bays with clean-out boxes. The system does not have a separator system for oils, but a debris collector is accessible and is emptied twice a year or as needed. The bay floors have a slight taper to the center of the bays to facilitate drainage.

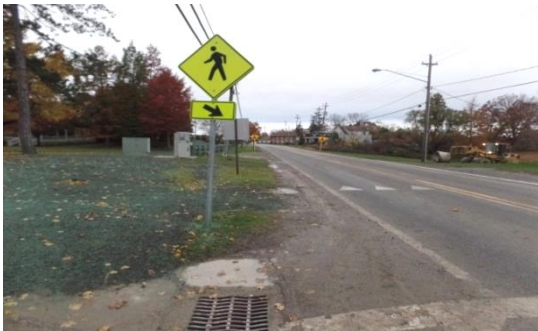
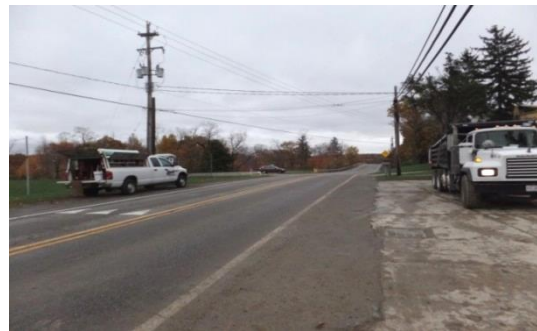
The ramp empties onto Concord-Hambden Road which is a 35 MPH roadway. Line of sight from both directions off the ramp is not an issue and normally does not create any safety concerns for apparatus leaving the station on a response. However, there have been several close calls with motorists who were exceeding the speed limit. There are no traffic control devices present for the department's use in accessing the roadway.

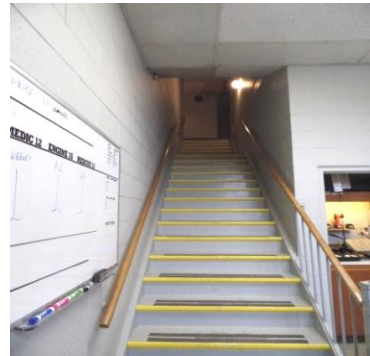
Stairwell from vestibule to dorm

Access to the second floor from the apparatus bay area is provided by means of the stairwell in the vestibule. The stairwell is not an enclosed design, which can allow dangerous fumes, gases and potentially fire to enter the dormitory area on the second floor. There are no smoke detection devices in the dormitory hallway area and only one electric-powered carbon monoxide detector, which is mounted midpoint in the hallway at the floor electrical outlet level. Doors leading from the dormitory hallway to the training room and kitchen are not fire-rated. Lighting is provided by recessed ceiling-mounted fluorescent fixtures.

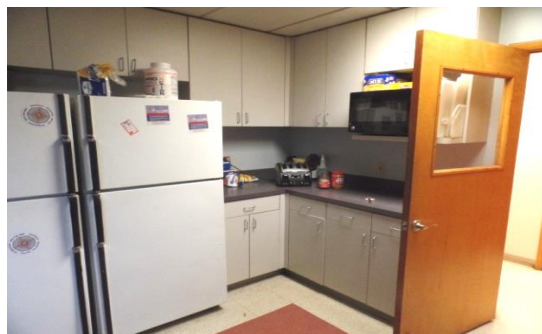
Kitchen and door to dormitory hallway

The kitchen is accessed from the dormitory hallway through a non-fire-rated door. The kitchen area is approximately 13' x 12' and features counter and wall-mounted cabinets, a dishwasher, microwave, two refrigerators and a gas-fired range. There is a hood system but it does not have a suppression system and the hood reportedly vents into the ceiling space above the range. The range also does not have an automatic shut-down control. The kitchen does not have a rate-of-rise heat detection system. The non-fire-rated-door would not prevent an intense spreading fire from entering the dormitory area.

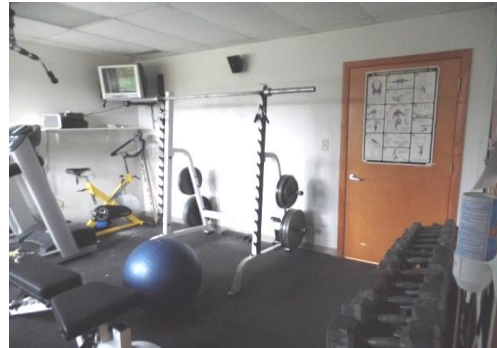
Physical Fitness Room

A physical fitness room is located next to the dayroom and is accessible from either the dayroom or training room. The room is approximately 13' x 14' and features a treadmill, exercise bike, Nautilus weight machine, free-standing weights, weight bench and scale. The room is available to all personnel during their shift. However, use during business hours creates a significant noise issue for the administrative offices. Because of the room's limited size and the space required to properly use some of the exercise equipment, the number of personnel that can safely workout at the same time is limited.

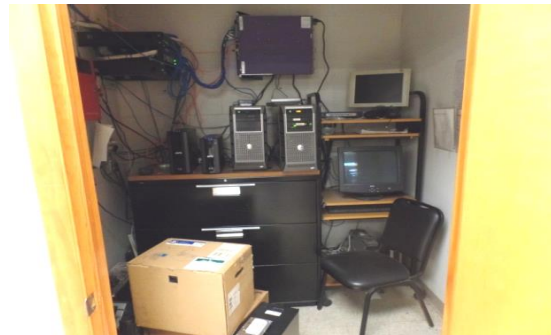
Computer room

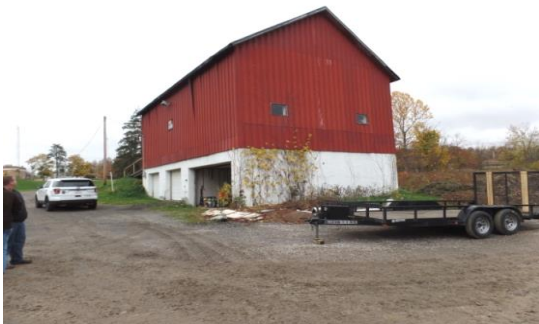
Storage space is again at an extreme premium forcing the trailer used for hauling the Gator to be stored outside. Attempts should be made to organize similar products into one location, neatly arranged and sorted to maximize the available space.

Barn storage and gator trailer

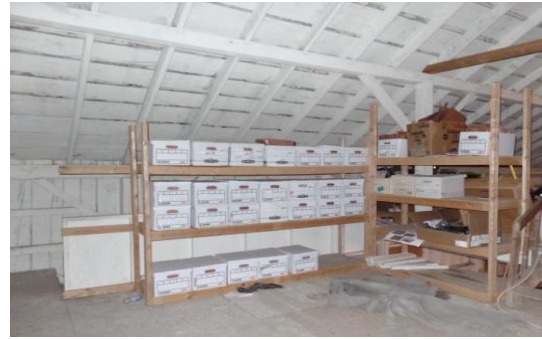
Third level record

It is recommended that fire department records be stored within a designated, restricted, secured location designed to protect the records from potential damage due to leaking water, smoke, or fire. This designated area should incorporate the use of fire resistant lockers, files, or cabinets. Consideration should also be given to protecting the designated storage area with the appropriate type of alarm system to provide notification in the event of an emergency.

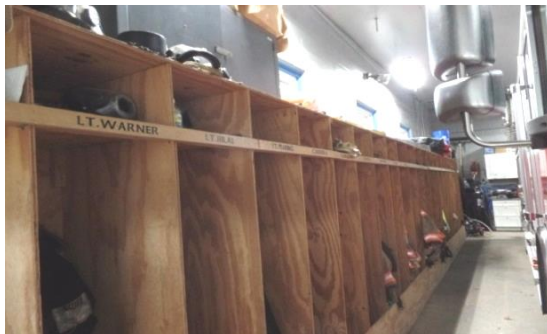
PPE lockers on south wall

The storage of firefighter PPE is less than ideal. This gear should be stored away from diesel exhaust (even when exhaust systems are installed) and away from chemicals and solvents. Adequate ventilation should be provided to avoid garment deterioration or contamination from potentially carcinogenic fumes, vapors or chemicals. Exposure to ultraviolet light and direct

sunlight should also be avoided. Studies have shown this exposure also leads to material degradation and shortens the life span of the garment. Numerous tools and equipment, such as fire hose, are subjected to the same exposures described for PPE. Although current circumstances limit any corrective actions, steps should be considered to relocate all unessential items from the bays if possible.

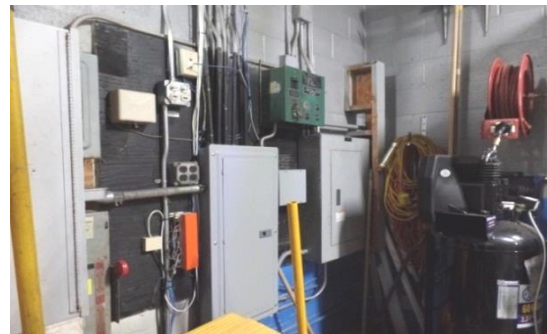
Electrical panels on south wall

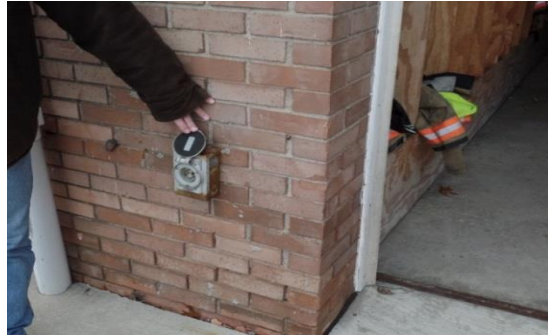
The building does not have a permanently installed standby generator; however, steps have been taken to modify the primary building electrical service to accept power from a portable generator. The generator is stored just below the electrical panels. Upon loss of power to the building, the portable generator is moved to the exterior southeast corner of the building where it can be plugged into a pre-wired electrical connection. The generator can then provide power to

External portable generator connection

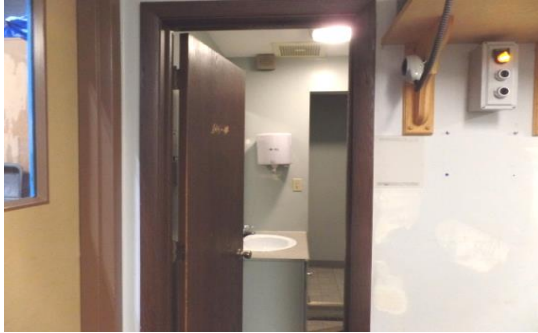
Old restroom and shower

In the original restroom area the rubber kick molding is coming off the wall leading into the shower area. Deterioration was noted to the wall just above this point as well as other areas in the room. Although mold was not observed, the lack of an air circulation system along with the presence of moisture creates an environment conducive for mold to grow. Regular cleaning with anti-mold cleansers and solutions is necessary to prevent mold development. There were no lockers available for personnel to use in either restroom area. The restroom/showers were not designated for male or female usage, but the entrance doors have locks that would allow the door to be secured during their use.

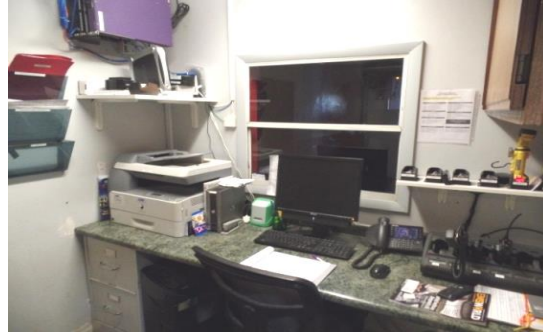
Radio and report space

Photos depict the area between the north bay and the addition where the report and radio counter and physical fitness room are located. It should be noted the report and radio counter is actually in the passageway between the bays and living area of the station. There are no fire or carbon monoxide detectors within this space. The limited space in the physical fitness room makes it extremely difficult to perform acceptable exercises in the prescribed manner.

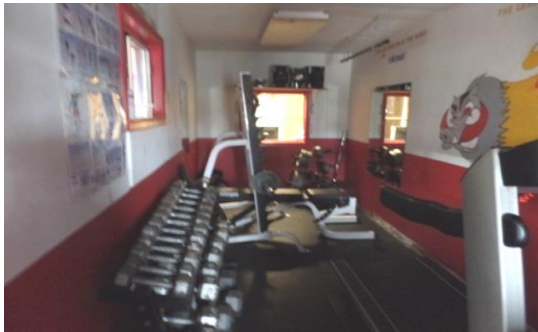
Physical Fitness Room

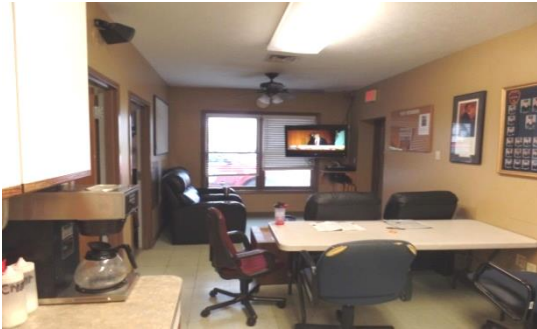
There is a ceiling-mounted circulation ventilation fan near the west end of this room for the recirculation of air. It was noted the vent must constantly be cleaned and only circulates room air with no exhaust to the outside or makeup air intake. There was a single smoke detector located on the ceiling next to the circulating vent. No carbon monoxide detectors are present.

Dayroom and kitchen area
